**Assessment of physical
vulnerability to flood in Saint
Lucia. Case studies: Castries old
Central Business District and
Dennery Village**

Thesis submitted to the Faculty of Geo-Information Science and Earth Observation of the University of Twente in partial fulfilment of the requirements for the degree of Master of Science in Geo-information Science and Earth Observation.

Specialization: Natural Hazards and Disaster Risk Management

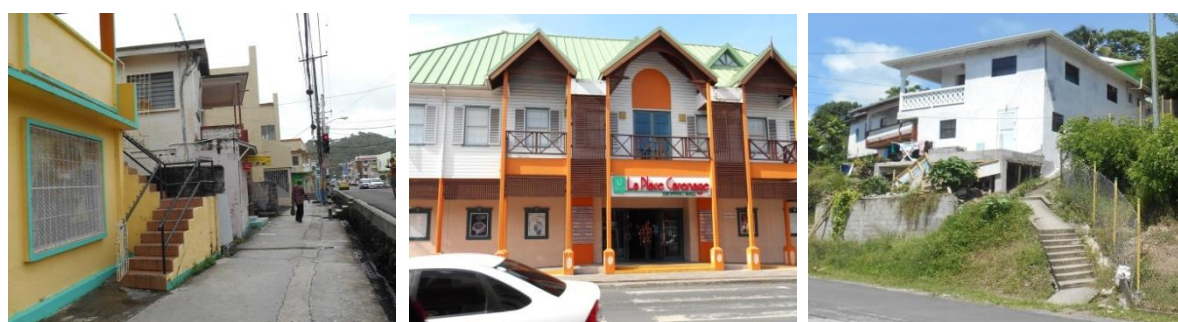
Figure 5-5: Building heights above the ground (with reference to the road)

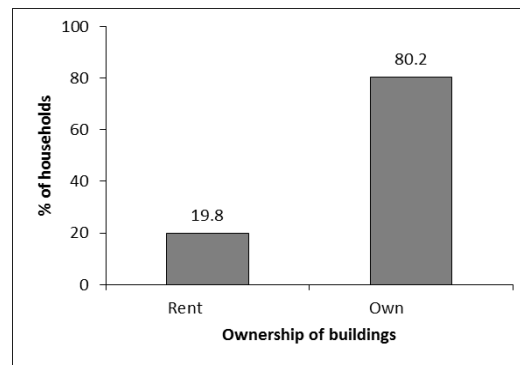
Figure 5-10: Ownership of household buildings

Based on the responses given by the respondents during the household interviews, 80% of the buildings are owned by the people, while 20% are on rent (see Figure 5-10). Ownership status may have an influence on the way people react or respond towards mitigation measures that needs to be implemented in safeguarding their buildings against flood.

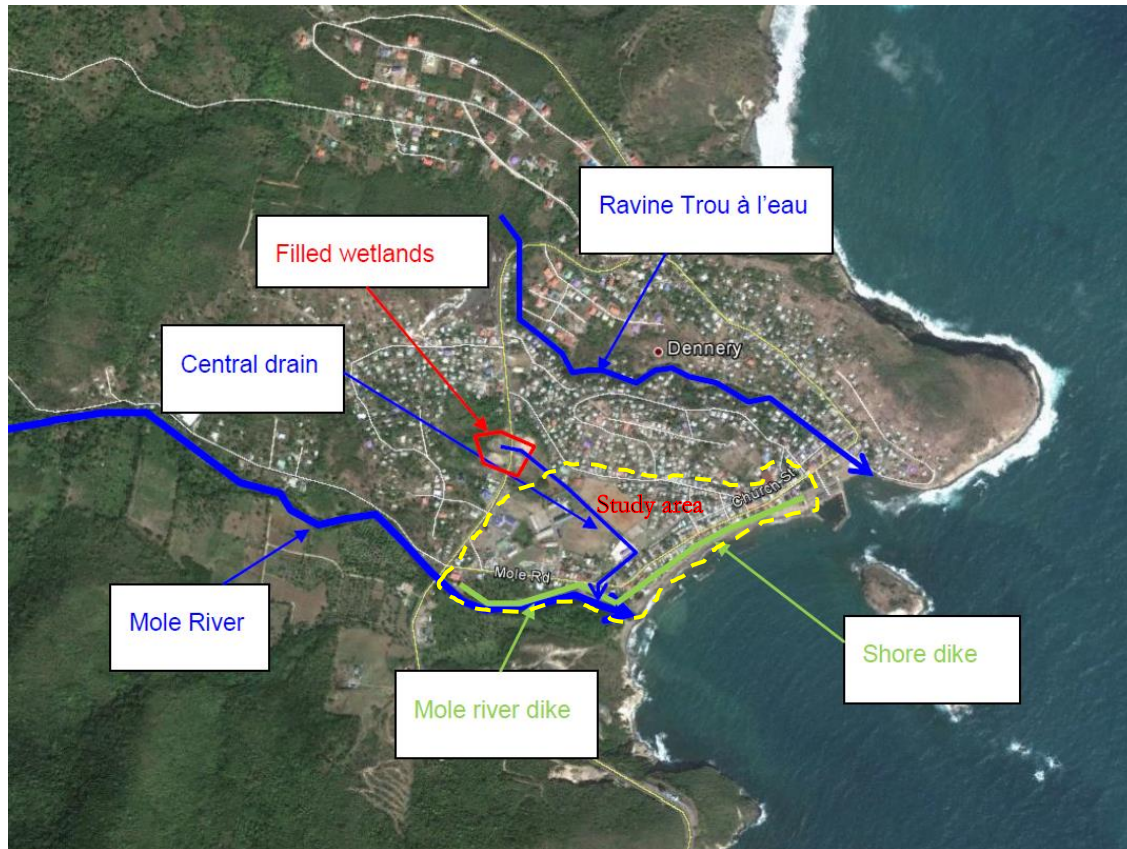
Figure 6-1: Characteristics of the study area

According to the respondents the flood water came from the Dennery River; and from the Ravine Trou à l'eau (see Figure 6-1) which is located outside the study area. The ravine is precisely at the northern, hilly environs of the study area.

Also, an analysis of the data from the interview showed that 70% of the inundated houses have flood proofing while the remaining did not have. This is an indication that most of the people are aware of the hazard (flood) and implement structural mitigation measures to protect themselves against it. The type of flood proofing found in the study area are, raised houses (i.e. houses with foundations that are raised well above the ground), stilts, dyke and stilts, and shutters for the door. Furthermore, among the entire flood proofing types the most common type is raised houses. It was also observed that there are structural mitigation works from previous projects such as the dyke at the Dennery River, along Mole road, and an embankment at the sea (shore dyke) to protect the people against flood (Figure 6-3). The location of these structural mitigation works in the study area is shown in Figure 6-1.

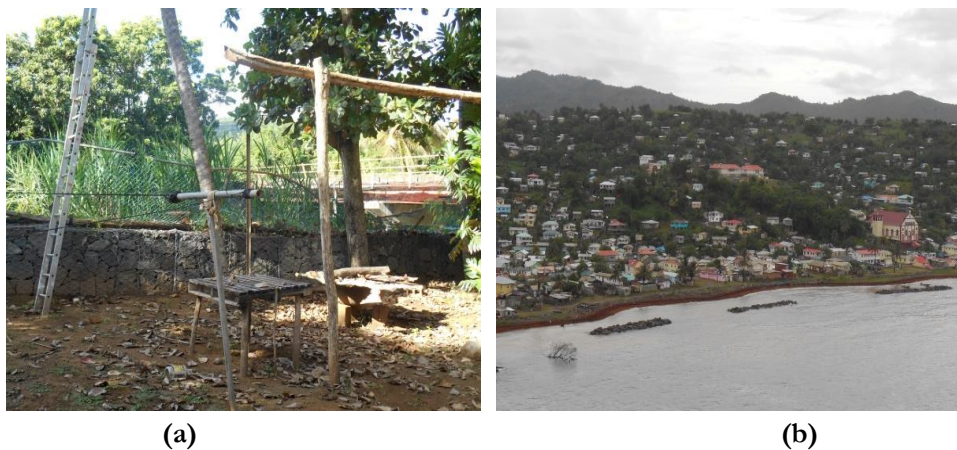
Figure 6-3: Structural mitigation work (a) Dennery (Mole) River dyke (b) Embankment at the sea

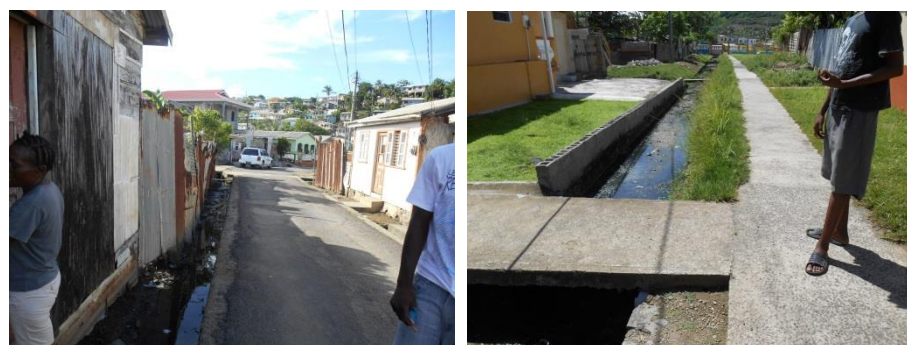
Figure 6-6: Drains filled with silt

During the interviews and general conversation with the people, knowledge about their perception on causes of flood and practices that exposes them to flood in the study area was gained. One respondent mentioned that some people still construct their buildings in the high flood prone area without raising the heights of the first floor well above the ground. Consequently, such people will be more affected by flooding. Another respondent mentioned that garbage from the hills settles and clogs the nearby drain to his house, which in turn obstructs the free flow of water and increases the amount of flood water. During site inspection to some of the drains the researcher also discovered that they were filled with silt (see Figure 6-6).

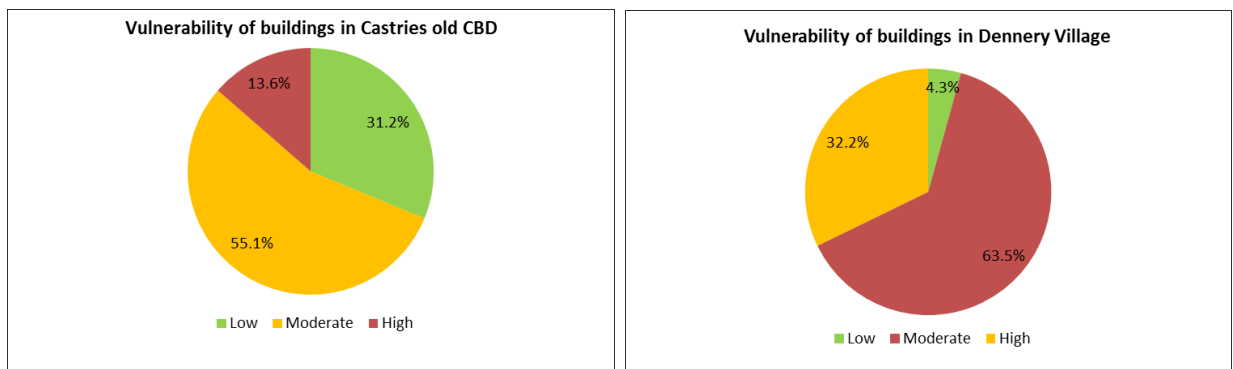
Figure 7-11: Physical vulnerability of buildings in Castries old CBD and Dennery Village

After the final physical vulnerability maps were derived, an analysis was performed to calculate the percentage of buildings that have low, moderate and high vulnerability to floods, for both study areas. The outcome of the analysis is presented in Figure 7-11. Additionally, the percentage of the occupancy type of buildings in the high vulnerability class was analysed for both study areas, and the result is presented in Table 7-8. It is important to note that the physical vulnerability map of Dennery Village that will be used for the comparison of both methods was not included in this analysis. This is because, the purpose of generating the vulnerability map is to compare if the results from the depth-damage and SMCE methods are similar.

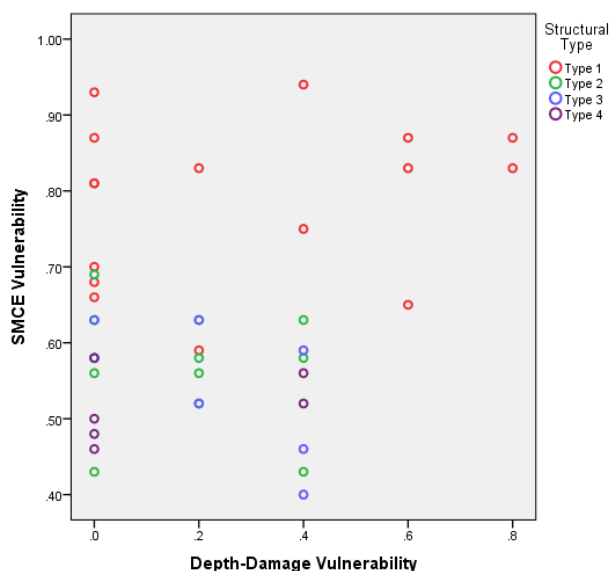
Figure 7-13: Scatter plot showing the vulnerability of buildings from Depth-damage and SMCE methods
