NATIONAL SCALE LANDSLIDE SUSCEPTIBILITY ASSESSMENT FOR DOMINICA AND SAINT VINCENT

Thesis submitted to the Faculty of Geo-Information Science and Earth Observation of the University of Twente in partial fulfilment of the requirements for the degree of Master of Science in Geo-information Science and Earth Observation.

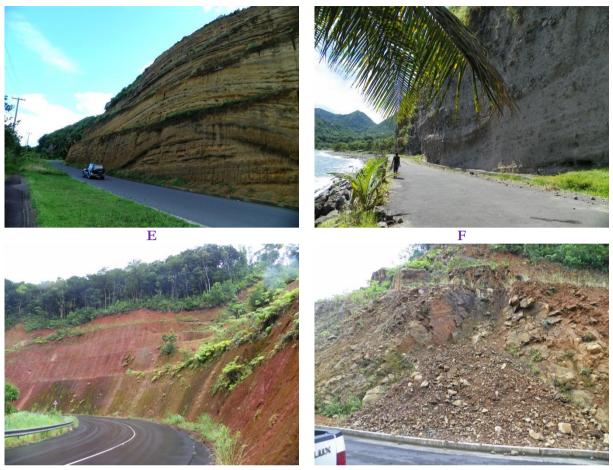
Figure 3. Examples of outcrops in volcanic deposits. a, b and c in Saint V incent: d, e and f in Dominica.
