# Caribbean Handbook on Risk Information Management

## 9.4 Damage assessment using high resolution imagery/ Activation of International Charter on Space and Major Disasters for Post Disaster Relief and Response

The objective of this Use Case is to describe the method for using high resolution images for building damage assessment from natural disaster like hurricanes and earthquakes.

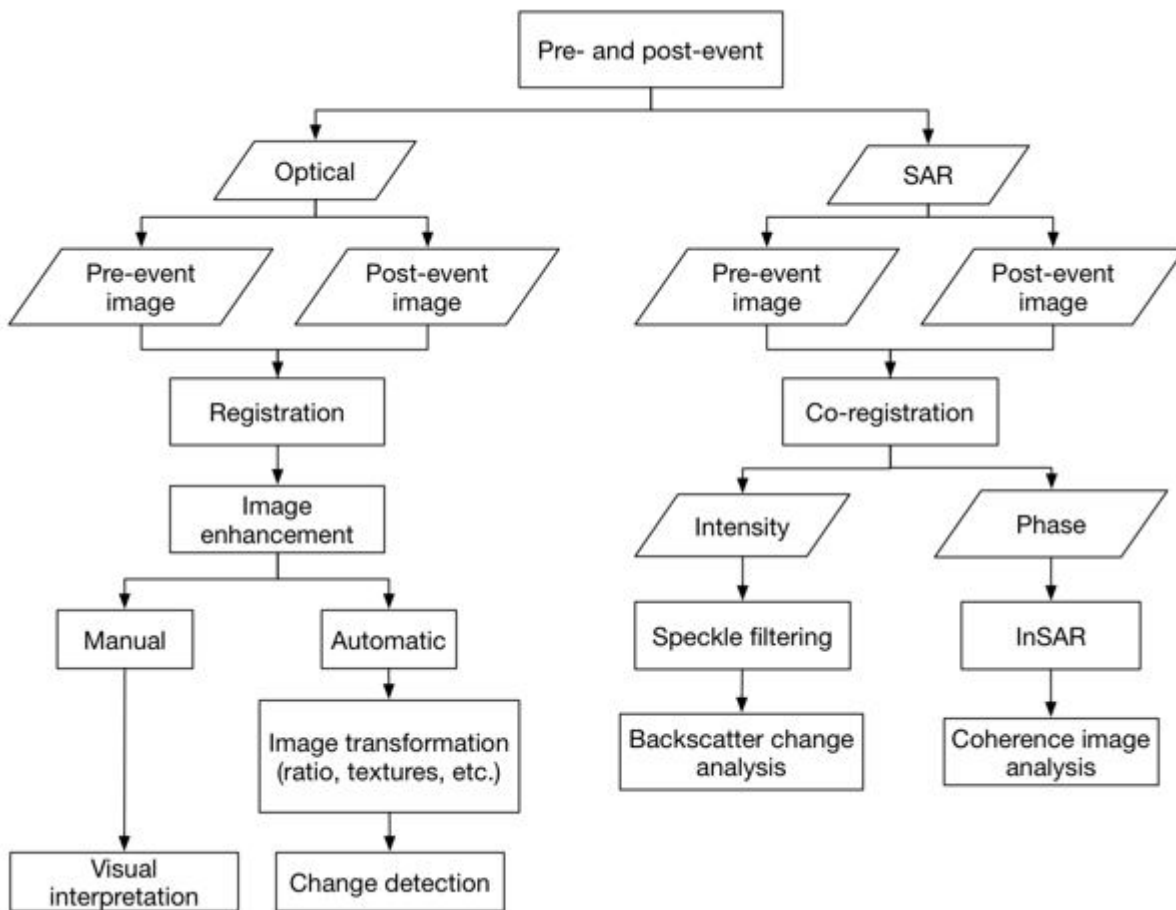
Image processing flowchart if both Pre- and post-event data are available

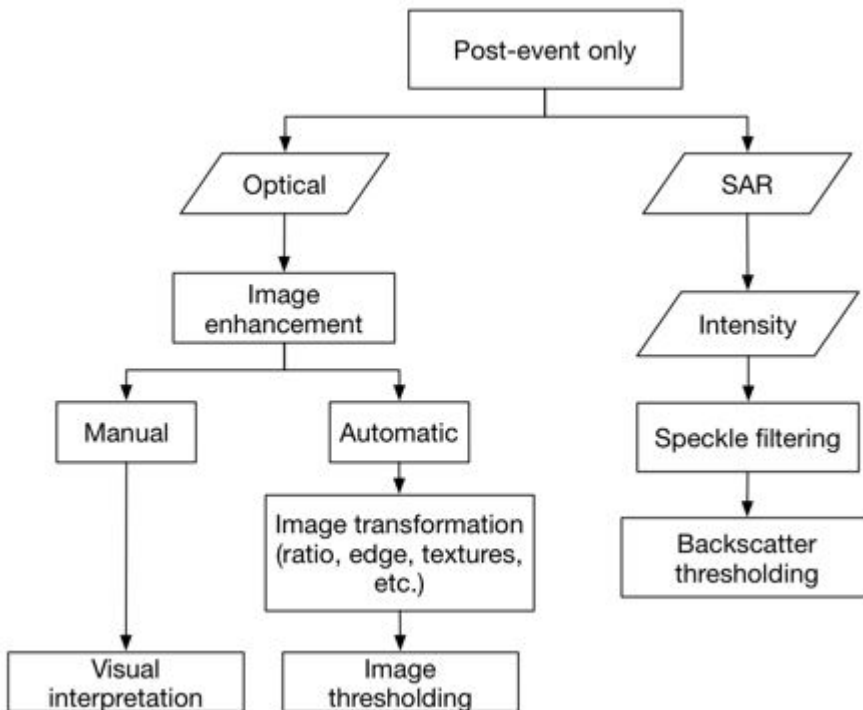
Image processing flowchart if only the post-event data are available

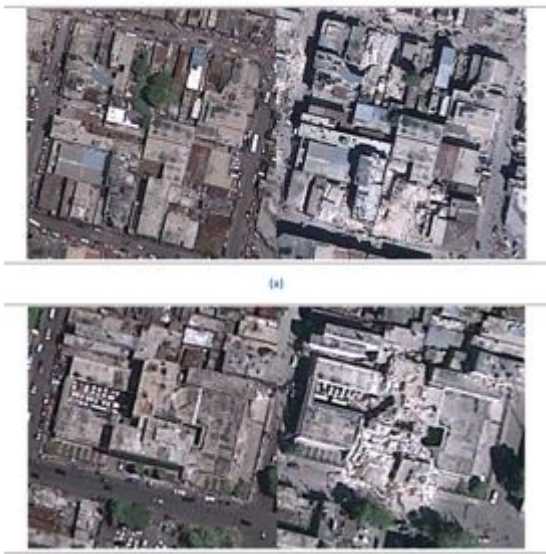
Figure 1: Examples of collapsed buildings as viewed in High-Resolution Imagery (50 cm) in Google Earth; pre-event imagery is shown in above and post-event imagery in below

Collapsed buildings are often observed as being much brighter than the surrounding buildings and in many cases, have rough textures. Changes in relative shadow heights may indicate possible soft-story failures or “pancaking.” This type of damages occurs in case of earthquakes when the bottom or lower story of a building is softer (i.e., less stiff) than the upper stories and thus collapses completely. Examples of some of these failures are viewed in Google Earth as presented in Figure 1 and Figure 2 below.

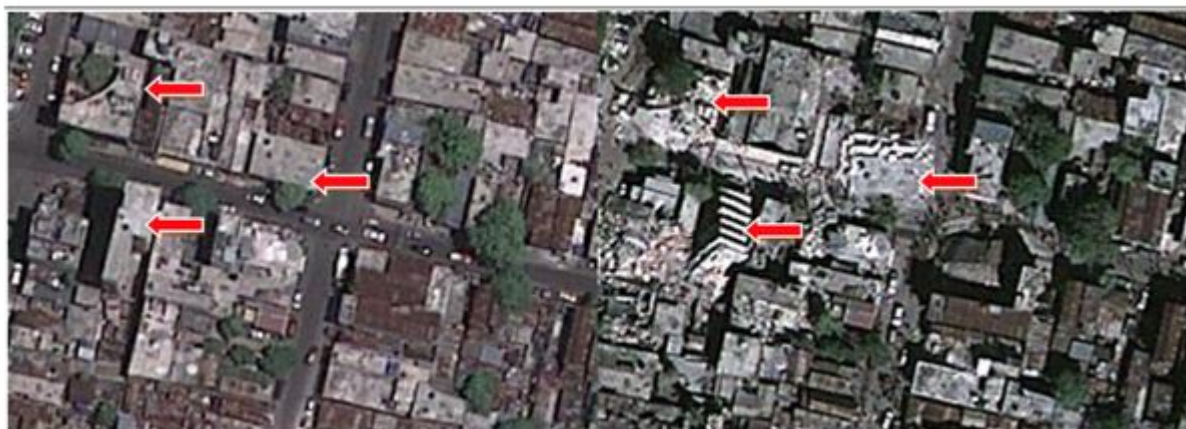
Figure 2: Pre-(left) and Post-event (right) imagery of "Pancaked" and "Stair-step" damage patterns

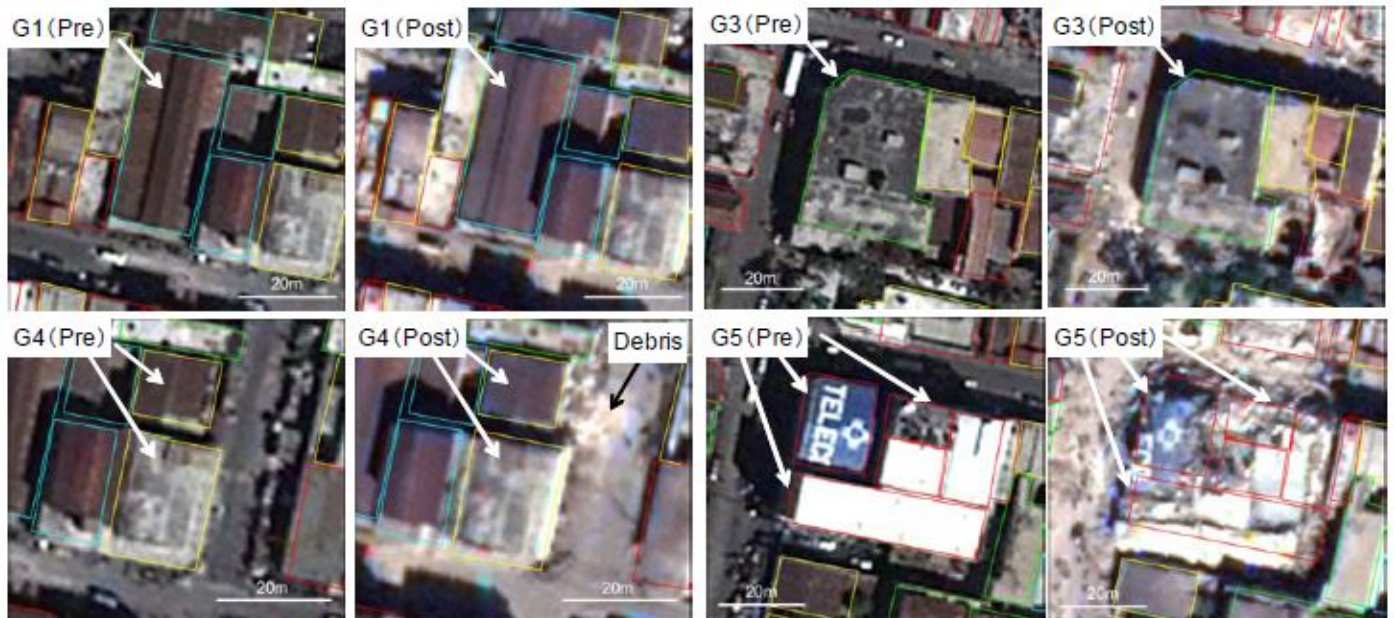
Figure 3: Building damage grade

examined the pre- and post earthquake images of 2010 Haiti earthquake as shown in Figure 3. There is no difference between the images in the G1 building. Similarly in the G3 building, significant changes on the roof and its surroundings between the images couldn't be found. Some part of the G4 building was damaged and debris around the building could be identified. The difference of the G4 building roof itself between the images is almost indiscernible. In case of G5-building, on the contrary, the roofs were completely destroyed and the debris produced from the collapsed building materials were scattered in and around the building, indicating that it is feasible to identify the collapsed buildings from the images. When the details of the images in the G5 buildings are carefully examined, the building edges were clearly identified and the homogeneous pixels were found on the roofs in the pre-event image. In the post-event image, on the other hand, the bright pixels and dark pixels were densely neighbored each other in the debris area. Since such image change can be analyzed by the image texture, the texture analysis was applied to the images for detecting the collapsed buildings.

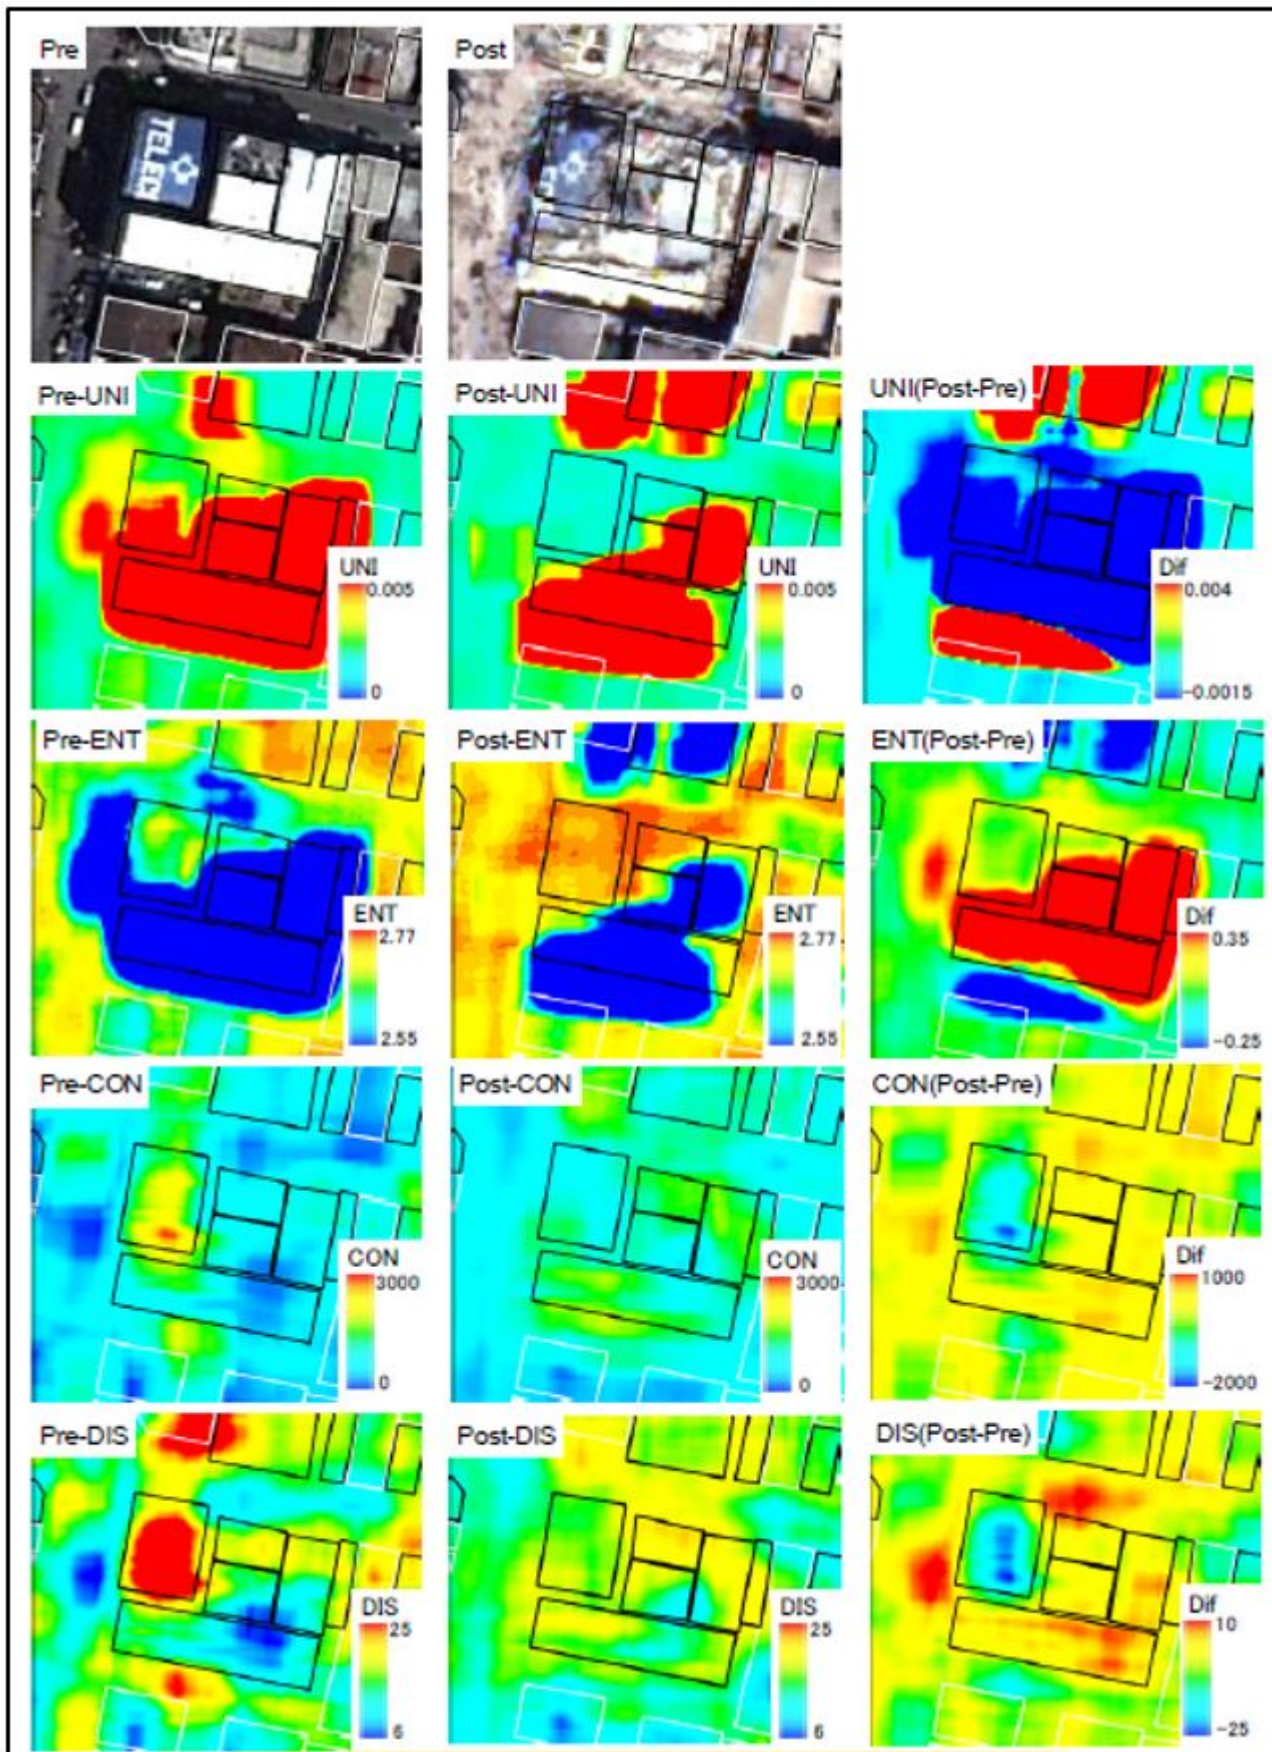
Figure 4: Image texture analysis based on the gray level co-occurrence matrix

Figure 4 shows the analysis carried out in Building G5. Image texture in and around the collapsed buildings was significantly roughed in the post-event image due to the debris produced from the buildings was observed. The UNI, ENT, CON and DIS represent uniformity, entropy, contrast and dissimilarity of the image, respectively. When the homogeneous pixels are concentrated, the image shows larger UNI. When bright pixels and dark pixels are dispersed, the image shows larger ENT. When the bright pixels and dark pixels are neighbored each other, the image shows larger CON and DIS. From the image texture analysis based on the gray level co-occurrence matrix, the DIS (dissimilarity), was identified as better classifier in detecting the collapsed buildings. It was found that the combination of the post-event DIS and the difference of DIS between the pre- and post-event images could provide more accurate result of the damage detection. The result showed that about 70% of the collapsed and less-damaged buildings were correctly classified by this method.
